# Fitting Instructions

Revo IS38 ETR V2 Turbo VAG 2.0 TSI/TFSI MQB

TITLE: **RV581 M100102 Working Instructions**

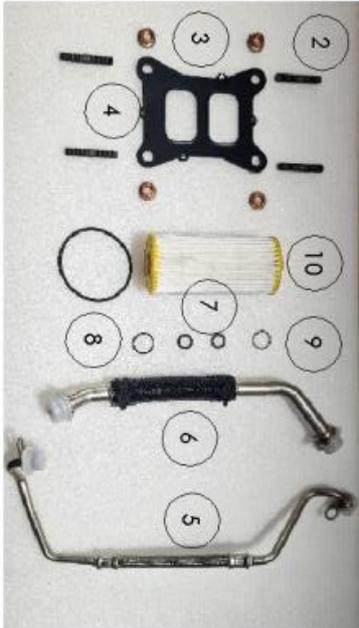
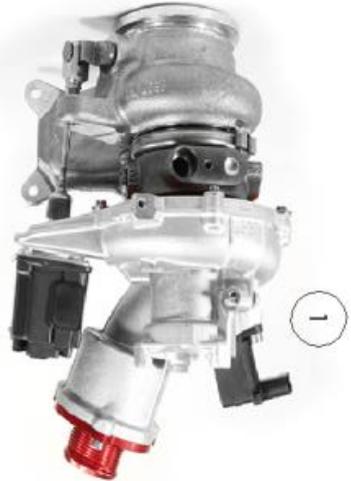
No.	Description	Qty.
1	Revo IS38 ETRV2 Turbo	1
2	IS38 Manifold stud	4
3	IS38 Manifold nut	4
4	IS38 Manifold gasket	1
5	06K145778AS Oil feed pipe	1
6	06K145735F Oil return pipe	1
7	WHT006123 Oil Feed O-ring	2
8	WHT006112 Oil return O-ring bottom	1
9	WHT0016113 Oil return O-ring top (green)	1
10	06L115562B Oil filter MQB (inc. O-ring)	1
11	Turbo box foam kit	1
12	Packaging - Turbo box	1

Please refer to the next page for the full fitting kit with a breakdown and description of each part in the kit. You should have received the full kit, as detailed, and all parts must be fitted.
